Ten Year-Environmental Test of Glass Fiber/Epoxy Pressure Vessels

James R. Faddoul
Lewis Research Center
Cleveland, Ohio

Prepared for the
Twenty-first Joint Propulsion Conference
cosponsored by the AIAA, SAE, ASME, and ASEE
Monterey, California, July 8-10, 1985

TEN YEAR ENVIRONMENTAL TEST OF GLASS FIBER/EPOXY PRESSURE VESSELS

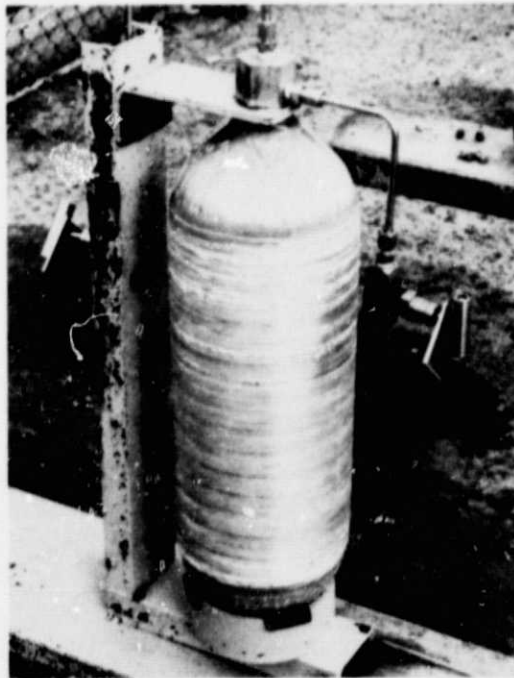
Figure 6. SCI fireman's pressure vessel after 10 years exposure to outdoor environment.

The outdoor environment of Cleveland, Ohio was deleterious to the physical condition of the unprotected pressure vessels. Loss of resin from the outer plies of the fiberglass was experienced by all bottles that had more than a few years of exposure. Figure 6 shows one of the SCI bottles after 10 yr exposure, and the extent of the exterior degradation is evident. The effects of the exposure were, however, somewhat variable. Some vessels would show almost 100 percent surface erosion and extensive fraying of the exposed glass fibers while other would have only localized circumferential bands that seemed to be affected.
